Advanced framework for post-flood assessment of steel truss bridges under data-constrained conditions: integrating engineering insights and empirical fragility models

Keywords: Structural performance, Poldokhtar flood, Steel truss bridge, Flood damage assessment, Empirical fragility curves

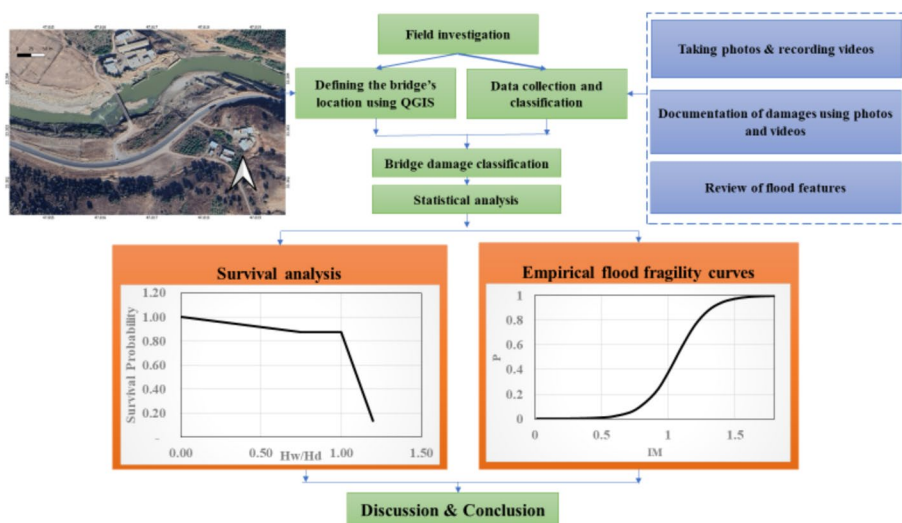
Fig. 1 Workflow of the proposed framework

The objective of this study is to systematically assess steel truss bridges' damage under flood hazards through a step-by-step methodological framework (Fig. 1). First, extensive field investigations are conducted before, during, and after flood events to collect photographs and videos that provide a detailed visual record of bridge performance under extreme conditions. Complementary information about flood conditions and river characteristics is obtained from official reports. The data gathered from both field observations and documentary sources are systematically classified to create a coherent dataset. Based on engineering judgment and visual inspections, bridge damage is categorized

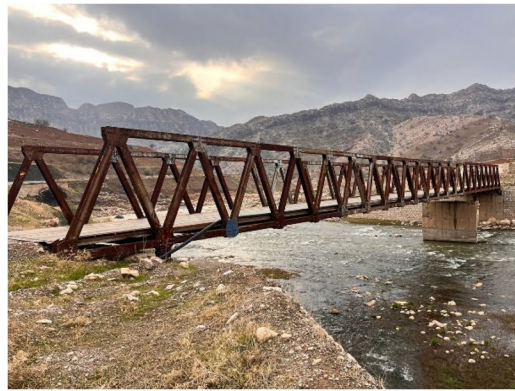
a

In bridges STB1, STB3, STB5, STB6, STB7, and STB8, the outflow was insufficient to handle the flood discharge due to debris damming on the upstream side of the bridges (debris damming phenomenon). This phenomenon caused water to accumulate on the upstream side of the structures, exerting additional pressure on their decks. Because of inadequate connection systems between the decks and the cap beams, piers, and abutments, the increased pressure from debris damming ultimately led to the collapse of these bridges (collapsed level).

In bridge STB1, additional pressure was exerted on the deck due to debris accumulation on the upstream side of the bridge, which reduced the outflow. Consequently, after the connection systems between the deck and the abutments failed, the deck slid and overturned (Fig. 5a). Figure 5b shows that the abutment was deformed and rotated due to flood-induced scouring, which led to the collapse of bridge STB2.

Upon examining the surface of abutments and cap beams of bridges STB3, STB5, STB6, STB7, and STB8, it is evident that there is no significant damage. This observation indicates that the decks in most of these bridges were placed on the substructures without any connection systems (Fig. 5f).

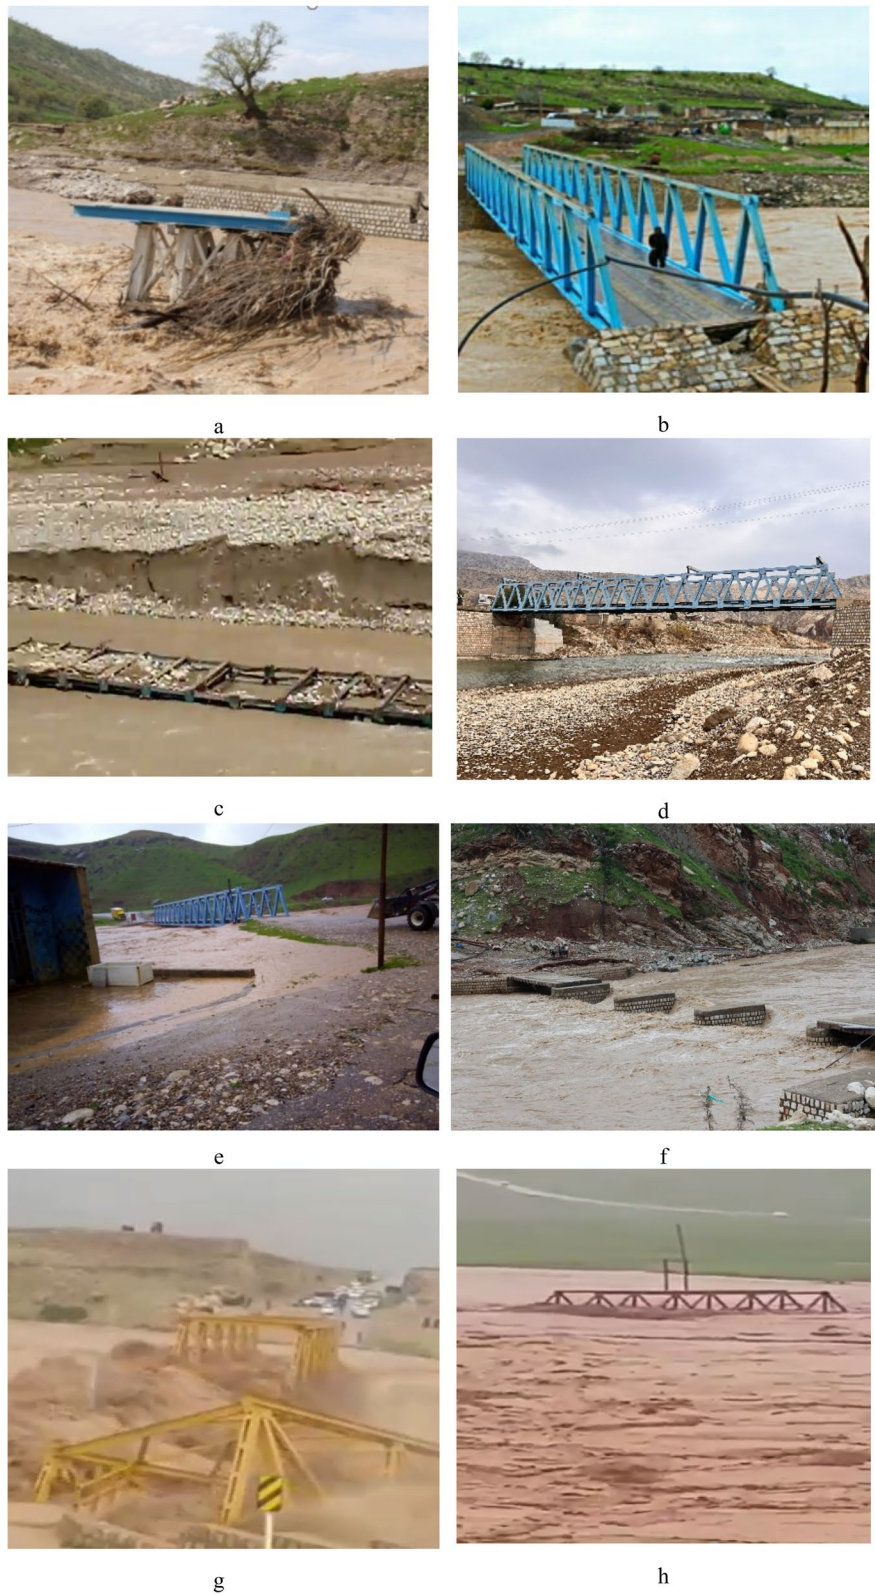
Fig. 5 Post-flood conditions of the investigated steel truss bridges: **a** collapsed STB1, **b** STB2 collapsed due to abutment scour, **c** STB3 after the flood, **d** STB4 after the flood, **e** STB5 during flooding, **f** collapsed STB6, **g** STB7 during flooding, and **h** STB8 during flooding

likely influenced by its plain topographic setting, which may have reduced the hydraulic demand. In contrast, the strong connection system between the deck and substructure played a decisive role in ensuring the bridge's stability and preventing structural damage. A post-flood view of bridge STB4 is shown in Fig. 5d.

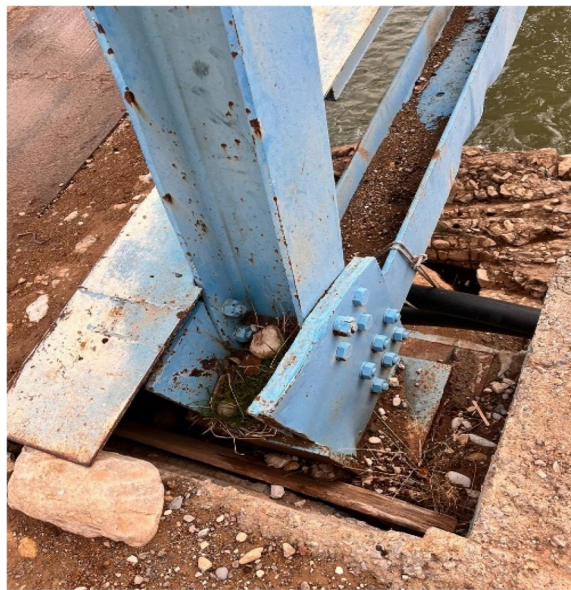
Fig. 9 Connection configuration between the superstructure and substructure in bridge STB4

Figure 9 displays that the bridge STB4 has proper connections between the deck and the abutments.

Although Bridge STB4 experienced an IM greater than one, it remained stable under flood conditions for two main reasons. First, it is located in a plain area, where floodwater can spread laterally, leading to a dissipation of hydraulic energy compared to mountainous settings. Second, the bridge deck is adequately connected to the abutments, which enhances its stability during the flood event.

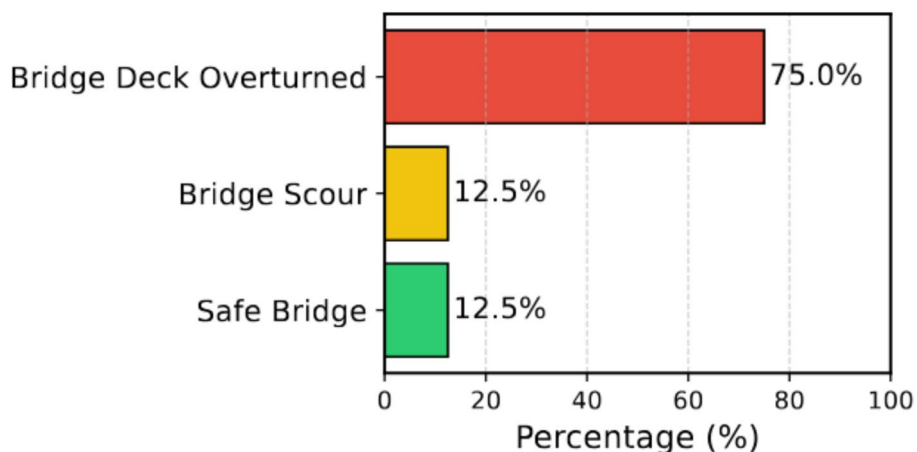
Fig. 10 Distribution of flood-induced damage states in investigated bridges

As shown in Fig. 10, 12.5% of the bridge failures are attributed to scouring, at hazard level I. At hazard level II. Only 12.5% of the studied bridges remained stable, and 75% of the studied bridges failed due to deck sliding and overturning at hazard level III, as the water level exceeded the bridge deck.

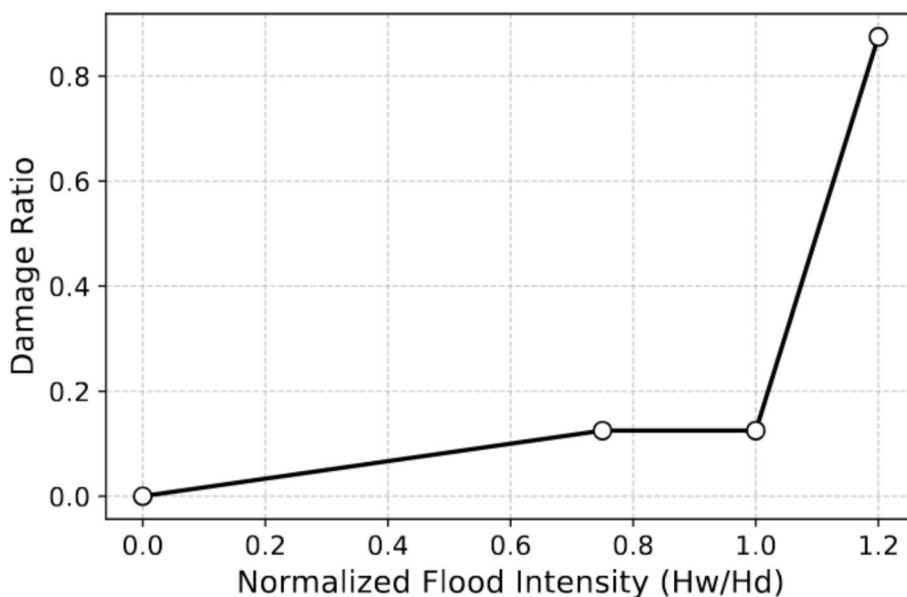
Fig. 11 Empirical flood vulnerability curve depicting the relationship between parameter H_w/H_d and the damage ratio of bridges

The empirical assessment of flood-induced vulnerability using the H_w/H_d index shows that, at hazard level I, bridge STB2 overturned due to scouring effects on its abutment. At hazard level II, no additional bridge failures were observed. At hazard level III, six bridges (STB1, STB3, STB5, STB6, STB7, and STB8) collapsed due to deck sliding and overturning caused by improper connections between the superstructure and substructure, instability of the bridges, debris damming, and excessive hydrodynamic forces. Only STB4 remained stable, demonstrating resilience under extreme flood conditions. In this context, the percentage of failed bridges at different hazard levels is analyzed (Fig. 11). The results from Fig. 8 indicate that when the

H_w/H_d parameter exceeds 1 (third hazard level), the rate of bridge failure increases significantly.

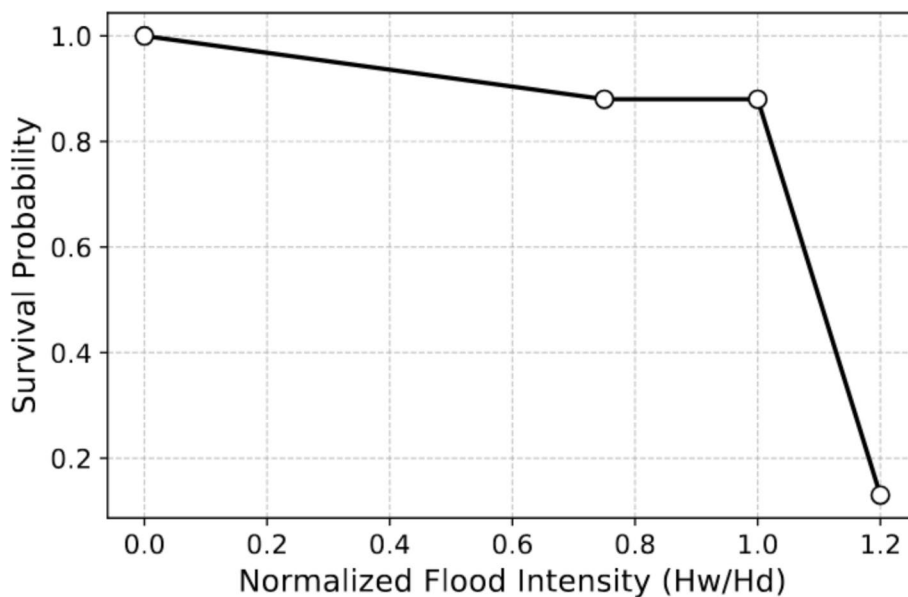
Fig. 12 Kaplan–Meier survival curve illustrating bridge reliability under varying flood intensity ratios (Hw/Hd)

Figure 12 presents the Kaplan–Meier survival curve for bridges under varying flood intensity ratios (H_w/H_d). When the H_w/H_d index is equal to 0.75, one bridge failure is recorded, reducing the survival probability to 0.875. No further failures occur when H_w/H_d index is equal to 1.0, and the survival probability remains unchanged. However, when H_w/H_d reaches 1.2, six additional bridges fail, leading to a sharp decline in survival probability to nearly 0.125. This steep drop indicates that most failures occur

once the flood intensity surpasses a critical threshold, emphasizing the importance of considering the H_w/H_d criterion in the design of river-crossing bridges to ensure reliability against severe flooding.

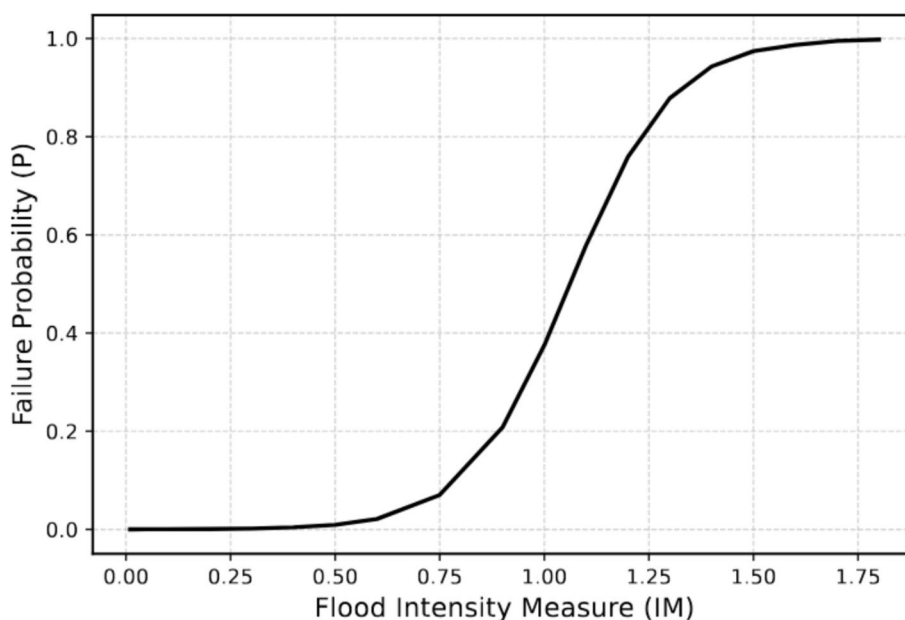
Fig. 13 Empirical fragility curve illustrating the probability of failure of steel truss bridges as a function of intensity measure

As presented in Fig. 13, the empirical fragility curve illustrates the increasing probability of failure of steel truss bridges with rising values of the intensity measure ($IM = H_w/H_d$). For example, when H_w/H_d is 0.1, the probability of bridge failure is as low as 0.034%. When the H_w/H_d index is equal to 1.5 (corresponding to water depths ranging from 0.01 to 1.8 m), the failure probability sharply increases to 97.4%. This probabilistic representation provides valuable insights into the vulnerability of steel truss bridges under flood conditions and serves as a robust tool for risk assessment and flood

management planning. The developed fragility curve represents a practical instrument for assessing flood-related risks and planning management strategies, enabling engineers, stakeholders, and policymakers to gain deeper insights into the susceptibility of steel truss bridges under diverse hydraulic conditions.
